POLYTERM® FLEXIBLE SMD TERMINATION

Performance verification of the Polyterm® flexible SMD termination was performed on the R15 (0805), R18 (1206), S41 (1210), S43 (1812), R29 (1808), S47 (2220), X43 (1812) and X44 (1410) size capacitors. These tests were conducted based on industry standards. JIS-C-6429, IEC-384-1, IEC 60068-2-21.

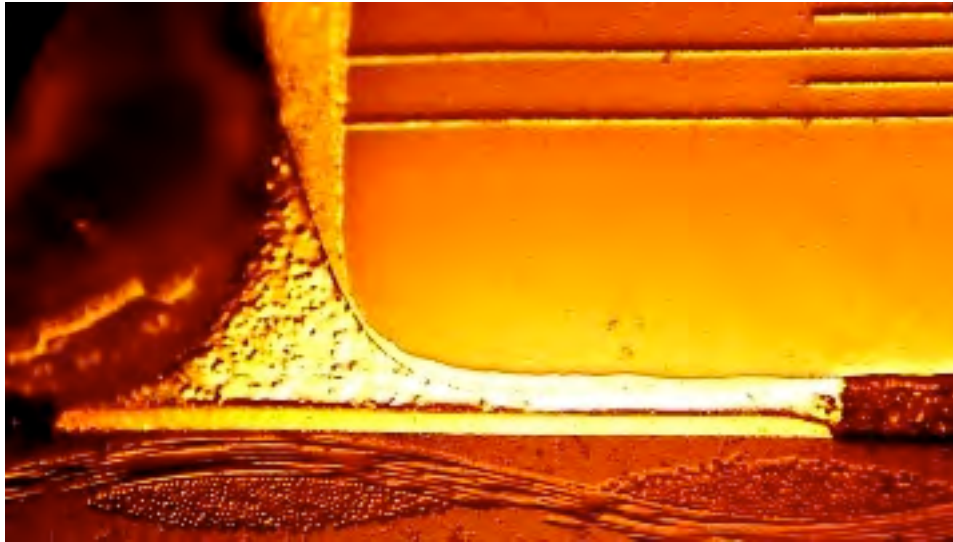
Figure 10 Undamaged termination 1mm deflection

Group 2) Samples were bent to varying degrees of deflection to provide photographic representation of how the polymer terminations perform and illustrate how failures manifest themselves. This test was performed using the S47 (2220) sample group (figures 10-14). One board for each mm of deflection was used.

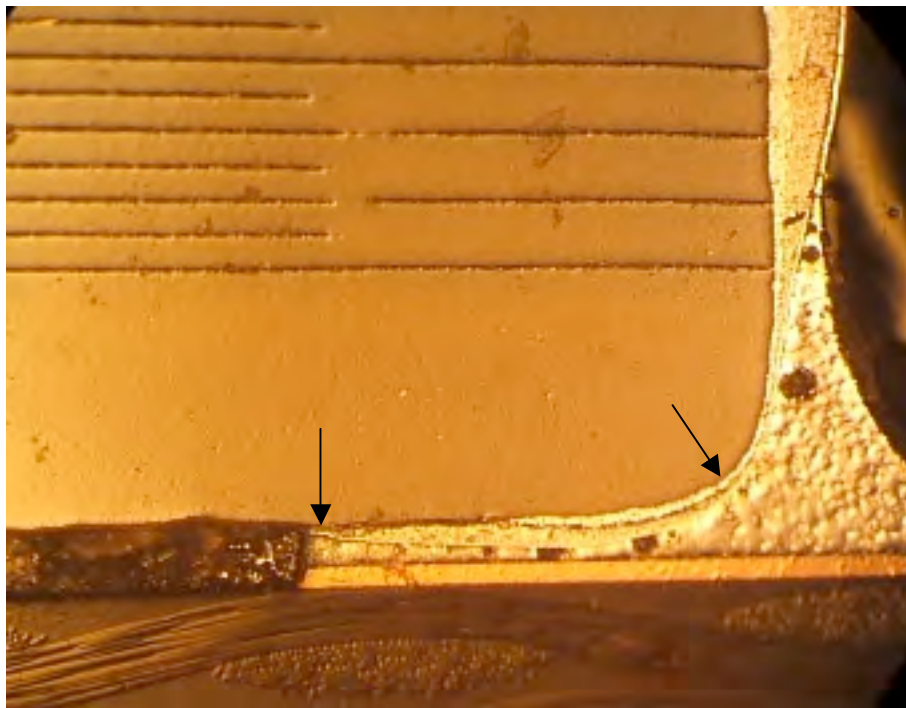
Figure 11 Partial separation of polymer 3mm deflection.

At 3mm only partial separation of the polymer was visible. The silver layer is clearly separating from the polymer with no ceramic damage visible.

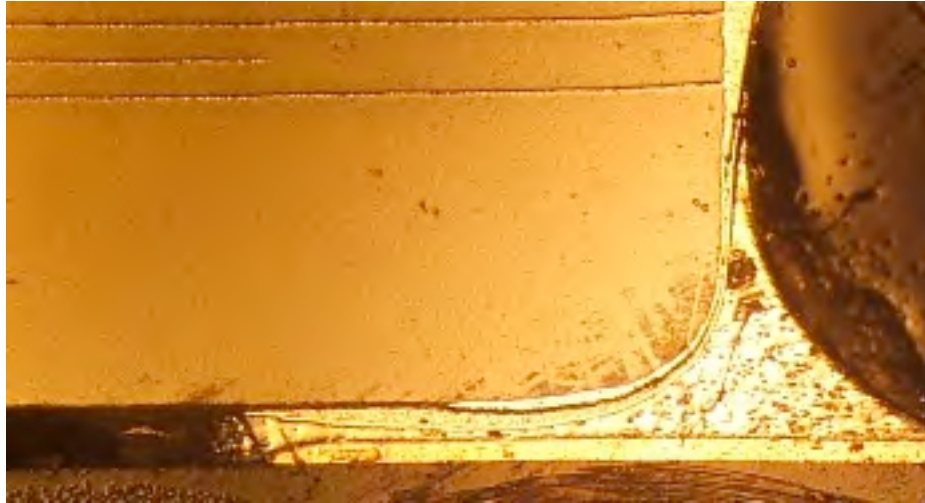
Figure 12 Partial Separation of Polymer 4mm

The photo in Figure 12 shows almost complete separation of the silver termination from the polymer layer. Although the polymer layer is partially separated the capacitor still operates normally. When returned to the original state all capacitors regardless of failure operated within specification.

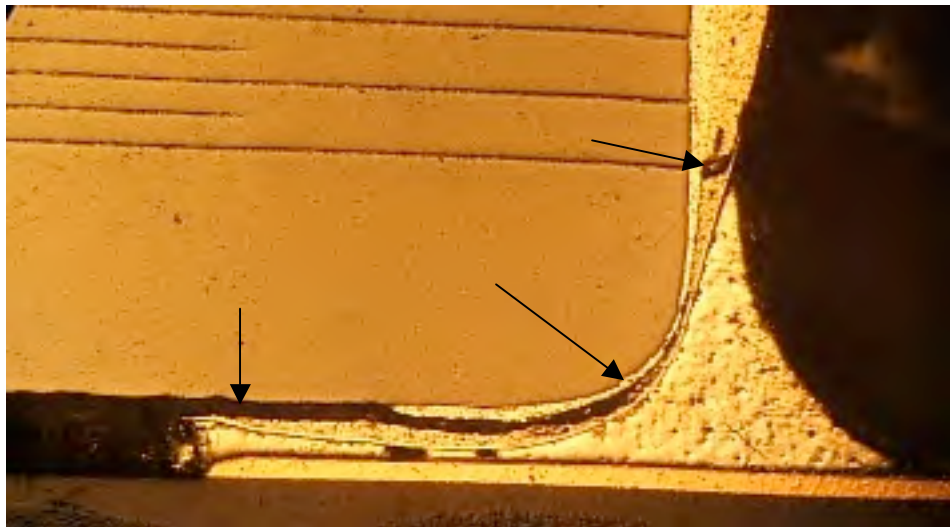
Figure 13 Complete Separation of Polymer Layer 5mm

Complete separation of the polymer layer may cause open capacitor, but ceramic failure was not observed. This will protect against the capacitor failing short causing catastrophic failure.

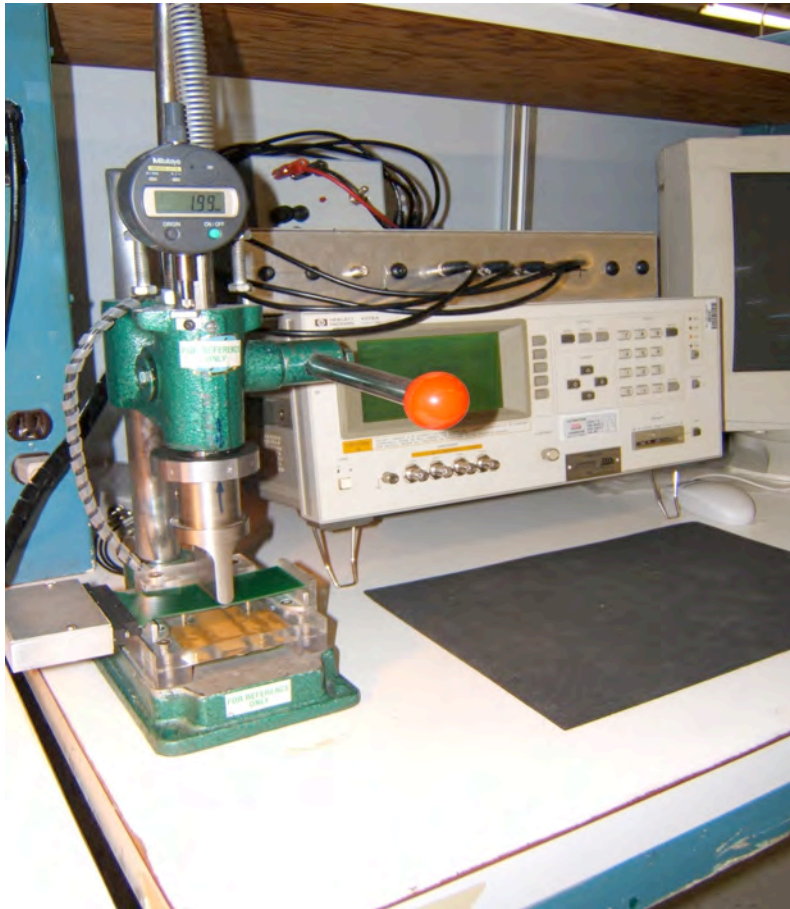
Figure 16 Flex Test Fixture W/CPU for Data Storage

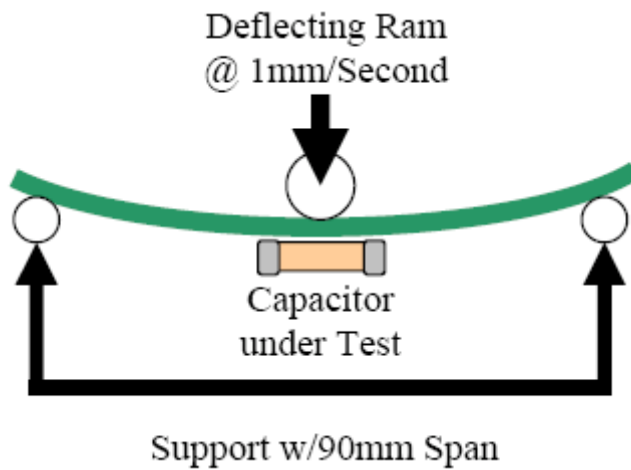
Figure 17 illustration of bend test
