## JOHANSON DIELECTRICS INC.

### Arc Season and Board Design Observations

John Maxwell, Director of Product Development, Johanson Dielectrics Inc.

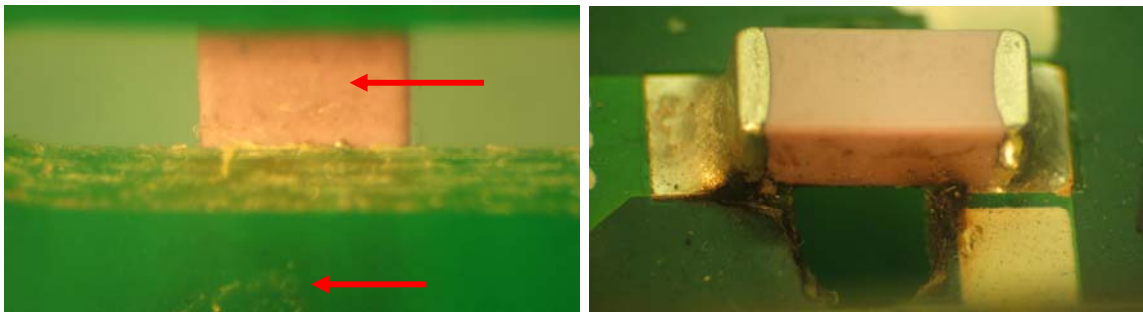
Figure 1. Field Failure Due to Water Soluble Flux Residue

a) Flux Residues on Chip & PWB Bottom

b) ARC Path in PWB Slot

Problems include test equipment correlation problems, test methods used for HV testing, but the big source of defects appear to be from a combination of the board layout, assembly process, choice of solder paste flux and cleaning where required. A large number of contract manufacturers around the world use water soluble flux solder paste because it is much more aggressive than No-Clean flux allowing for wider reflow process windows and minimizes component solderability problems. Unfortunately organic acids used in water soluble solder paste are very active and if the assembly is not adequately cleaned those flux residues start their damage and are difficult to remove. Now we are faced with high leakage currents, low arc voltages and assembly failures. Add humidity and we have a new ARC season. An interesting ARC season failure is shown in Figure 1. The board was reflow soldered using water soluble solder paste but not completely cleaned. The board design used a 2mm slot beneath 1808 case size high voltage safety capacitors. The use of slots are a typical high voltage board design technique. Complete and thorough cleaning of all flux residues is mandatory when this design technique is used with water soluble flux. There were droplets of flux residue on the assembly bottom and visible flux residues on the bottom of all 1808 size safety capacitors. The burned arc path shown in Figure 1 is along the slot edge in the PWB following flux residues.

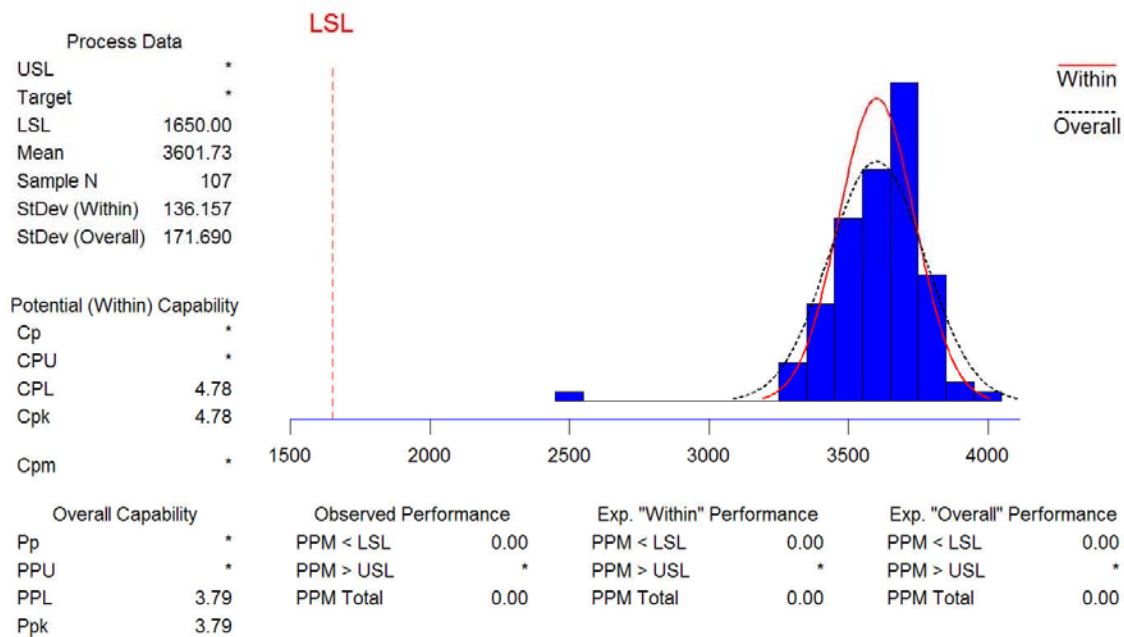
Figure 2. AC Breakdown Results for Test Lot of 302R18W121KV4 Capacitors

### Process Capability Analysis for 302R18W121KV

These capacitors chosen for this experiment are 1206 case size X7R 120pF and are designed for 1500VAC withstanding voltage commonly found in larger safety capacitors. A 107 piece sample of these parts was tested to AC breakdown with the results shown in Figure 1.

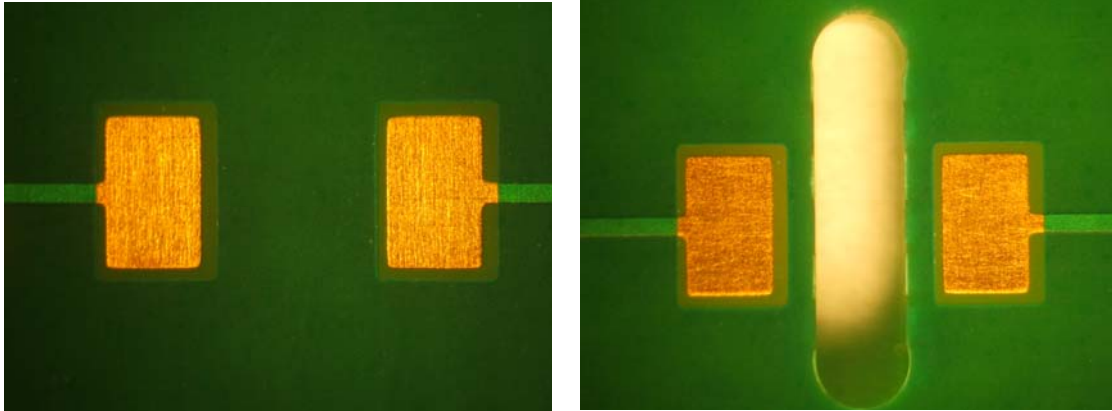
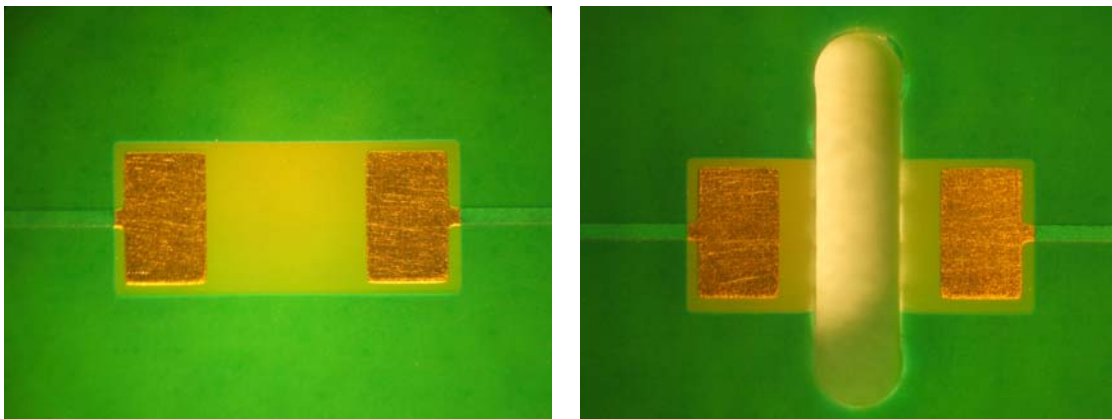
Figure 3. Evaluation Board SMT Pad Variations

a) Solder Mask between Pads

b) Solder Mask & Slot between Pads

c) No Solder Mask between Pads

d) No Solder Mask but Slot between Pads

Board layout variations included solder mask between pads, no solder mask between pads, solder mask with a 0.040" (1mm) wide slot between pads and no solder mask with a 0.040" slot between pads. A larger slot was not practical for 1206 sized capacitors because of pad to pad spacing of 0.080" (2mm) was used. Figure 3 shows each layout variation for reference. Removing solder mask from between pads allows solvent access during cleaning when water soluble flux is used and minimizes flux flow between the capacitor pads due to capillary forces during reflow soldering.

Square pads were used as they are most commonly encountered on end customer's boards. Additionally square pads are the easiest to draw in board layout programs. Each evaluation board had 80 positions for each pad/solder mask/slot variation for increased confidence levels in the results. Bare board arcs were from pad corner to opposing pad corner as expected as square pad corners will have the highest electric field gradients.

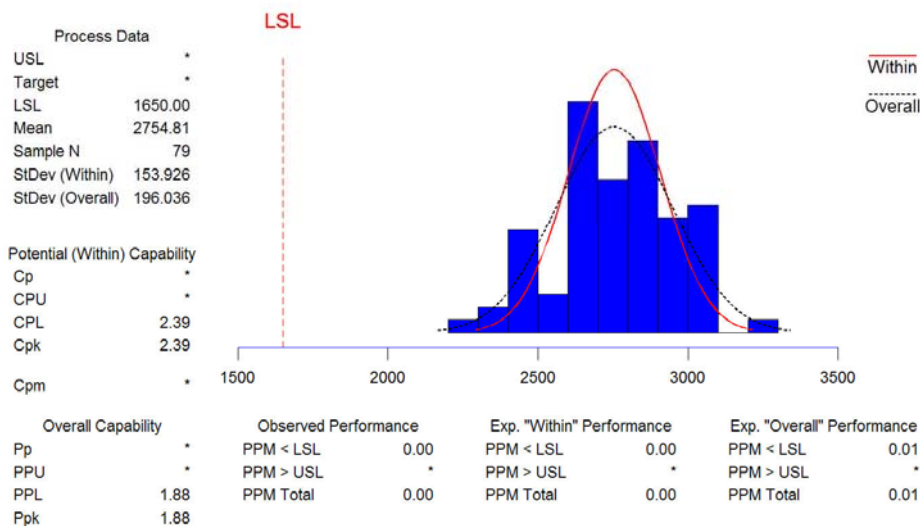
Figure 5. AC Breakdown Distribution 48 Hours 85°C/85%RH Exposure

Water Soluble Solder Paste, No Solder Mask with 1mm Slot

Examining both the mean of the breakdown voltages and the actual distributions shown in Appendices 2 and 3 are revealing. Solder mask between pads was consistently the poorest performer in AC breakdown testing in these experiments. Slots between pads were consistently the best performers as expected. No solder mask between pads was comparable with the layout option of solder mask and a slot between the capacitor pads. Figures 4 and 5 are the distributions for No-Clean solder paste with no solder mask between pads and water soluble solder paste with solder mask between pads with a 0.040" (1mm) slot. Both assemblies underwent 48 hours exposure at 85°C/85%RH.

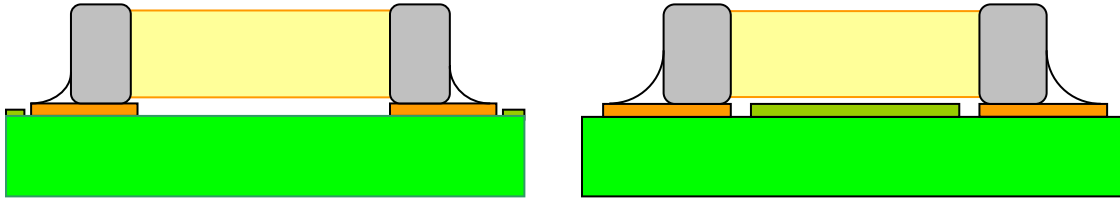
Figure 6. Solder Mask Layout Options

The data are consistent with eliminating high voltage slots where allowed and removal of solder mask between pads. Figure 6 represents a chip soldered to pads with and without solder mask showing the added gap between chip bottom and PWB surface.

a) No Solder Mask between Pads      b) Solder Mask between Pads

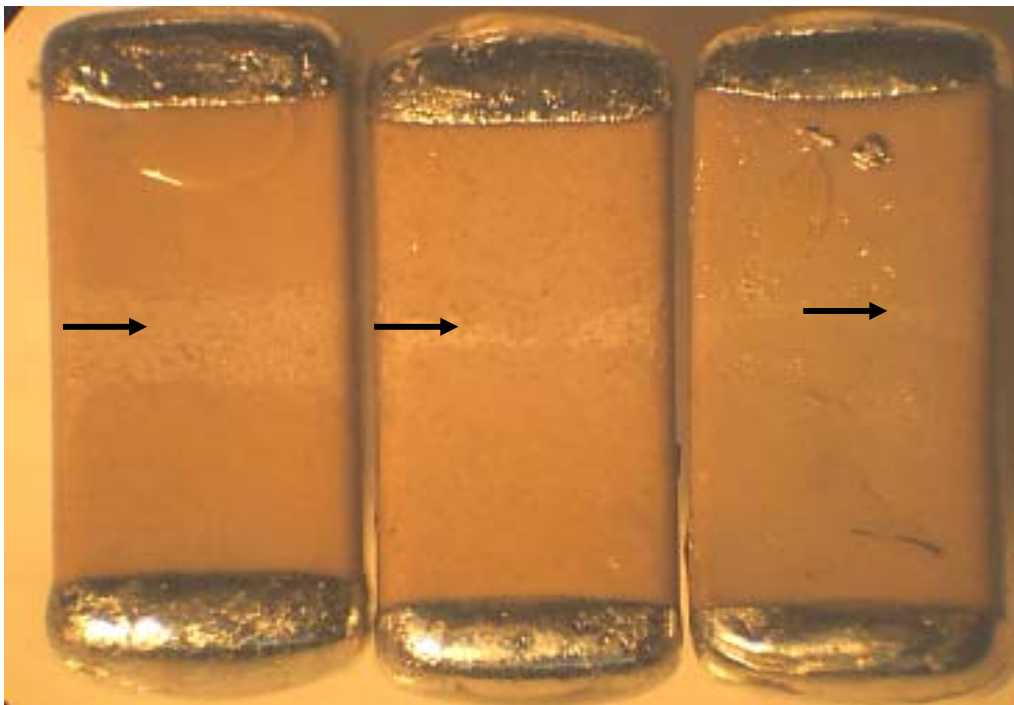
Figure 7. Bottom Side of Capacitors Showing Trapped Flux Residue Leading to Failure

Flux residues are trapped between capacitor bodies and solder mask during reflow soldering when the flux is liquid. This is due to capillary forces wicking the flux between the solder mask and capacitor body. Figure 7 shows three parts removed from a board that suffered ARC season defects. The flux is clearly visible in this photo. The parts were removed by placing the assembly on a hot plate and were plucked off using tweezers when the solder reflowed. These particular boards had a 2mm slot between pads but failed 1500VAC during HiPot testing. Bottom side of capacitors showing flux residues trapped between capacitor bodies and solder mask. The flux flow stopped at the PWB slot and has arrows pointing to the flux gaps.

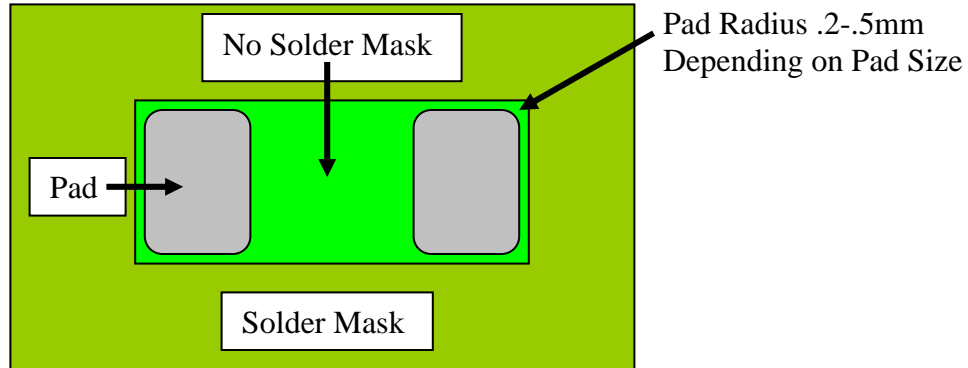
Figure 8. High Voltage Surface Mount Pad Radius Suggestions

In addition to eliminating solder mask between pads, the pads themselves should have radiuses instead of rectangular corners. All arcs emanated from pad corners due to those locations having the highest electric field gradients when exposed to high voltage fields. Adding a radius at each corner will reduce field gradients aid in high voltage performance. Suggested pad radiuses are shown in Figure 8.

The data are consistent with cost savings by eliminating slots where possible by eliminating solder mask between pads. There is the additional benefit of creating cleaning access if water soluble solder paste is used in board assembly. And finally spreading out field gradients by adding a radius to pads can aid in improving AC breakdown performance. Each layout suggestion needs to be evaluated in new designs as each design will have unknown quirks.

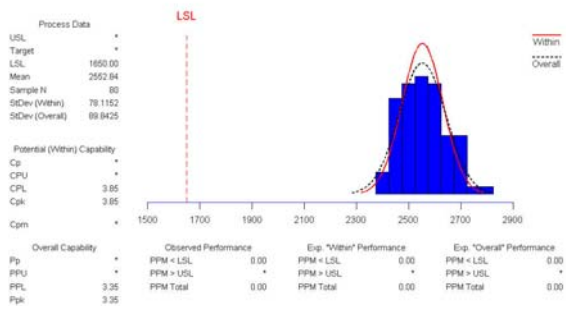
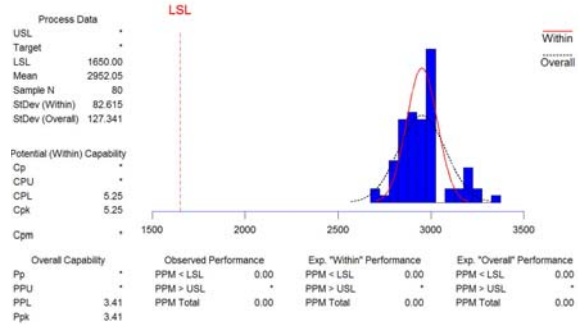
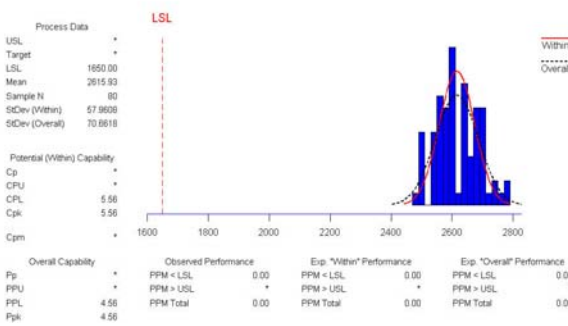
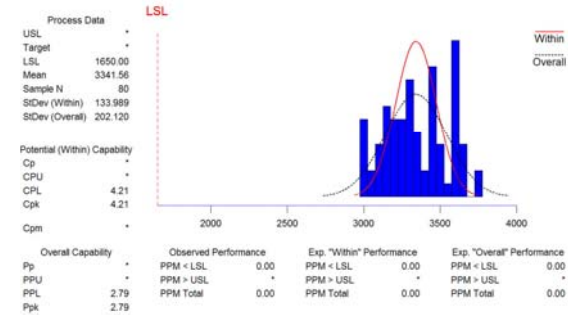
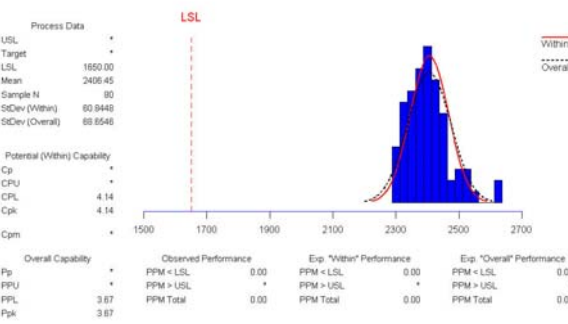
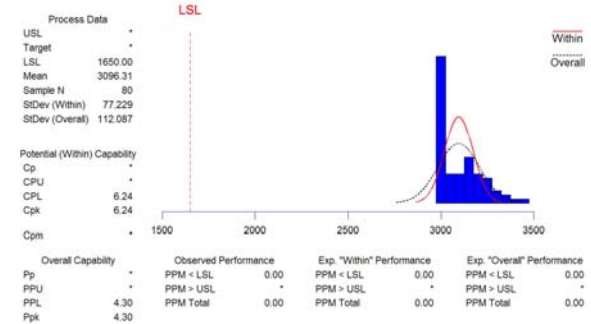
## Appendix 1. Bare Board and Sn63 NC Solder Paste AC Breakdown Results

Process Capability Analysis for Solder Mask

Process Capability Analysis for Sn63 NC Solder Mask

Process Capability Analysis for Solder Mask with slot

Process Capability Analysis for Sn63 NC Soldmask w/Slot

Process Capability Analysis for No Solder Mask

Process Capability Analysis for Sn63 NC No Solder Mask

The experimental procedure consisted of exposing both bare boards and assemblies to AC breakdown. A bare board as received was tested for AC breakdown voltage distribution. A second evaluation board had Sn63 No-Clean solder paste stenciled on the pads and reflowed. Those results are listed in Appendix 1 and are used as a baseline for comparisons with capacitors mounted to boards with different fluxes and humidity exposure. What is interesting is that the board AC breakdown capability significantly increased after exposure to reflow soldering temperatures. After components were soldered to the boards and exposed to 48 hours of 85°C/85%RH those breakdown voltages returned to values consistent with the bare board in an as received condition. Real world assemblies will absorb moisture after soldering and depending on where the assemblies are manufactured, stored and the 48 hours of humidity exposure the results inline with the board in its as received condition. The data for the bare board and those with capacitors solder to it is consistent with reflow soldering drying out the assembly.

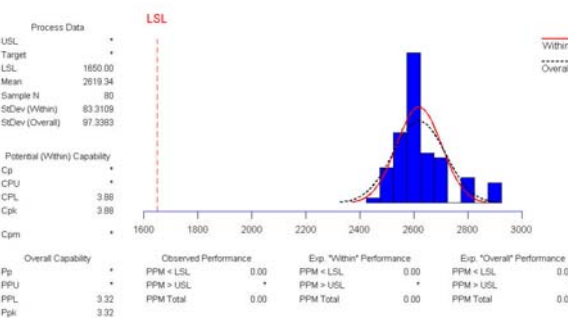
Process Capability Analysis for No Solder Mask with slot

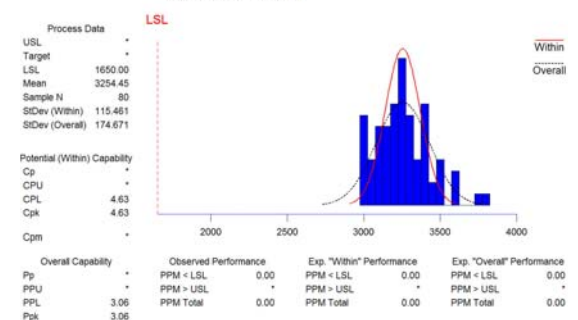
Process Capability Analysis for Sn63 NC No Solder Mask w/Slot

Appendix 2 lists AC breakdown results for capacitors reflow soldered to an evaluation board with No-Clean solder paste, tested approximately 18 hours after reflow soldering and an assembly that was exposed to 85°C at 85% RH for 48 hours and then tested 1 hour after the board was removed from humidity exposure. Appendix 3 has assembled board breakdown results approximately after two hours after cleaning. This assembly used water soluble solder paste. The other breakdown data is for an assembly with capacitors and water soluble solder paste, reflow soldered, cleaned and exposed to 85°C/85% RH for 48 hours. This assembly was tested to breakdown within 2 hours of humidity exposure. Table 2 is a summary all of the AC breakdown results shown in the appendices.
