Arc Season and Board Design Observations

John Maxwell, Director of Product Development, Johanson Dielectrics Inc.

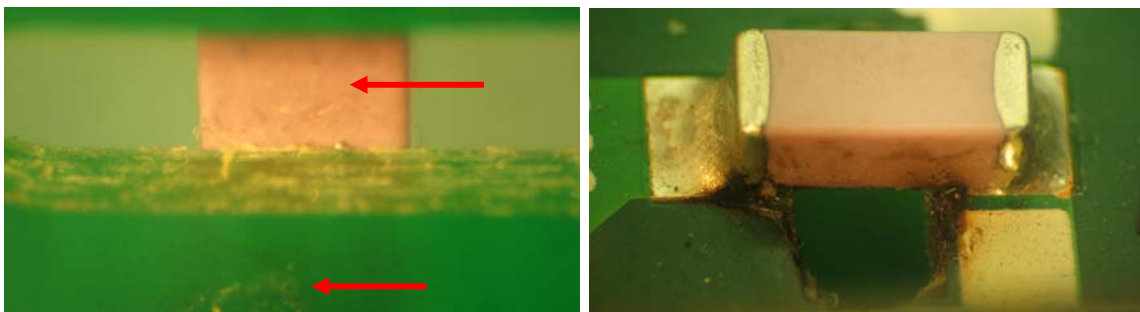
Figure 1. Field Failure Due to Water Soluble Flux Residue

a) Flux Residues on Chip & PWB Bottom

b) ARC Path in PWB Slot

Problems include test equipment correlation problems, test methods used for HV testing, but the big source of defects appear to be from a combination of the board layout, assembly process, choice of solder paste flux and cleaning where required. A large number of contract manufacturers around the world use water soluble flux solder paste because it is much more aggressive than No-Clean flux allowing for wider reflow process windows and minimizes component solderability problems. Unfortunately organic acids used in water soluble solder paste are very active and if the assembly is not adequately cleaned those flux residues start their damage and are difficult to remove. Now we are faced with high leakage currents, low arc voltages and assembly failures. Add humidity and we have a new ARC season. An interesting ARC season failure is shown in Figure 1. The board was reflow soldered using water soluble solder paste but not completely cleaned. The board design used a 2mm slot beneath 1808 case size high voltage safety capacitors. The use of slots are a typical high voltage board design technique. Complete and thorough cleaning of all flux residues is mandatory when this design technique is used with water soluble flux. There were droplets of flux residue on the assembly bottom and visible flux residues on the bottom of all 1808 size safety capacitors. The burned arc path shown in Figure 1 is along the slot edge in the PWB following flux residues.

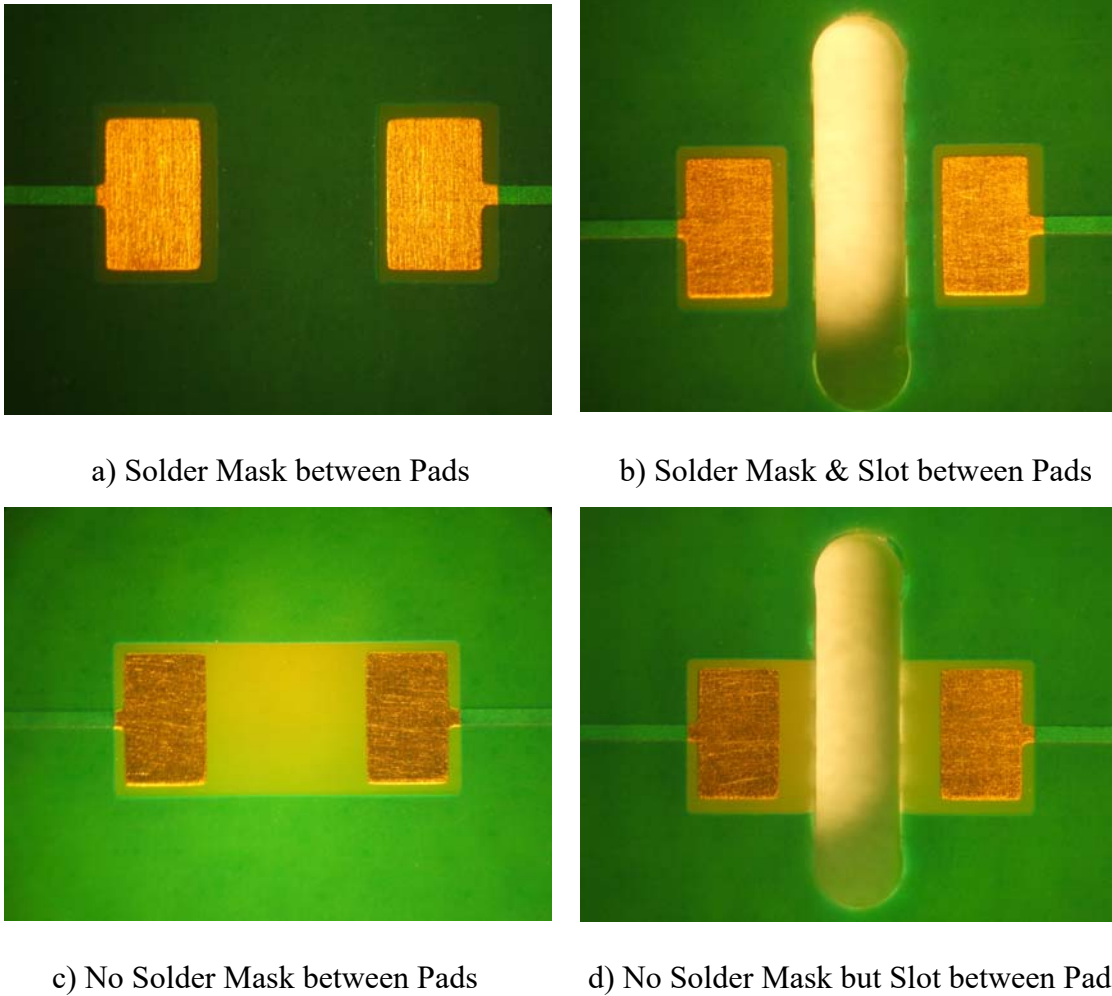
Figure 3. Evaluation Board SMT Pad Variations

Board layout variations included solder mask between pads, no solder mask between pads, solder mask with a 0.040” (1mm) wide slot between pads and no solder mask with a 0.040” slot between pads. A larger slot was not practical for 1206 sized capacitors because of pad to pad spacing of 0.080” (2mm) was used. Figure 3 shows each layout variation for reference. Removing solder mask from between pads allows solvent access during cleaning when water soluble flux is used and minimizes flux flow between the capacitor pads due to capillary forces during reflow soldering.

Square pads were used as they are most commonly encountered on end customer's boards. Additionally square pads are the easiest to draw in board layout programs. Each evaluation board had 80 positions for each pad/solder mask/slot variation for increased confidence levels in the results. Bare board arcs were from pad corner to opposing pad corner as expected as square pad corners will have the highest electric field gradients.

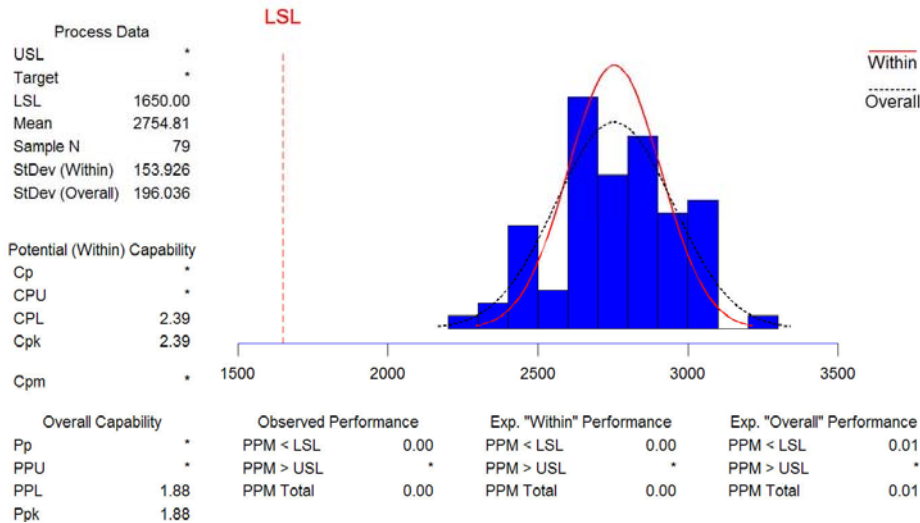
Figure 5. AC Breakdown Distribution 48 Hours 85°C/85%RH Exposure

Water Soluble Solder Paste, No Solder Mask with 1mm Slot

Examining both the mean of the breakdown voltages and the actual distributions shown in Appendices 2 and 3 are revealing. Solder mask between pads was consistently the poorest performer in AC breakdown testing in these experiments. Slots between pads were consistently the best performers as expected. No solder mask between pads was comparable with the layout option of solder mask and a slot between the capacitor pads. Figures 4 and 5 are the distributions for No-Clean solder paste with no solder mask between pads and water soluble solder paste with solder mask between pads with a 0.040” (1mm) slot. Both assemblies underwent 48 hours exposure at 85°C/85%RH.

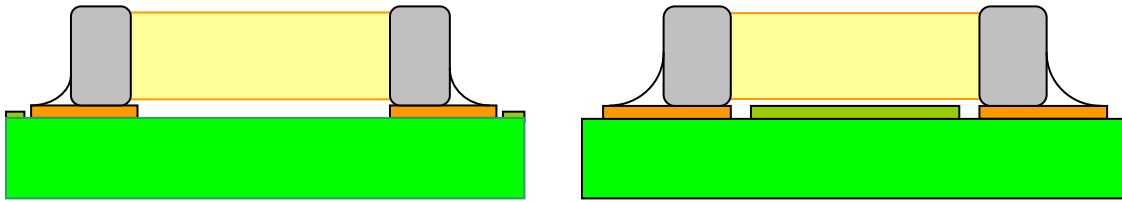
Figure 6. Solder Mask Layout Options

a) No Solder Mask between Pads b) Solder Mask between Pads

The data are consistent with eliminating high voltage slots where allowed and removal of solder mask between pads. Figure 6 represents a chip soldered to pads with and without solder mask showing the added gap between chip bottom and PWB surface.

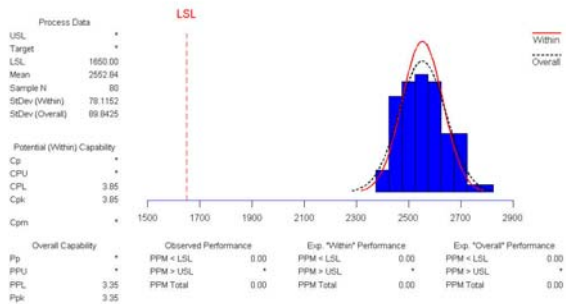
Process Capability Analysis for Solder Mask

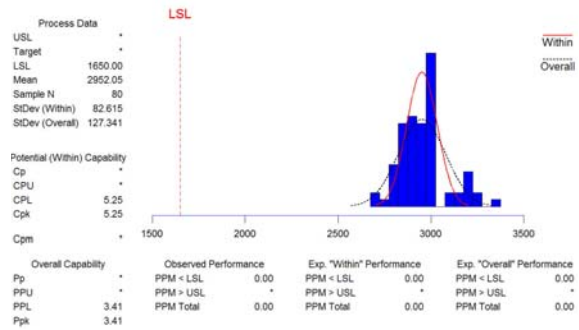
Process Capability Analysis for Sn63 NC Solder Mask

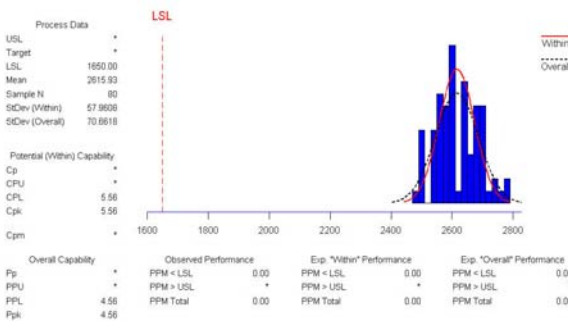
Process Capability Analysis for Solder Mask with slot

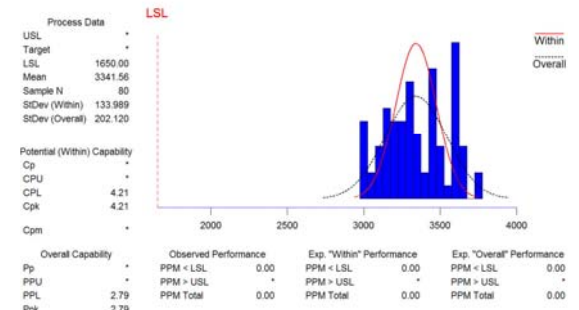
Process Capability Analysis for Sn63 NC Soldmask w/Slot

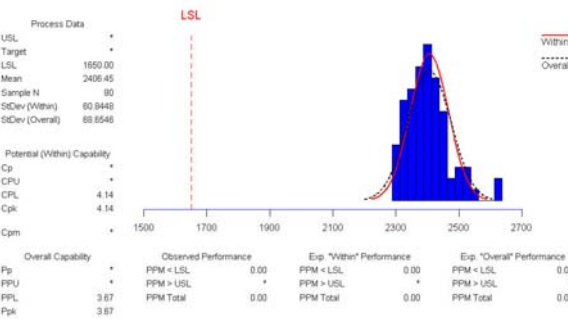
Process Capability Analysis for No Solder Mask

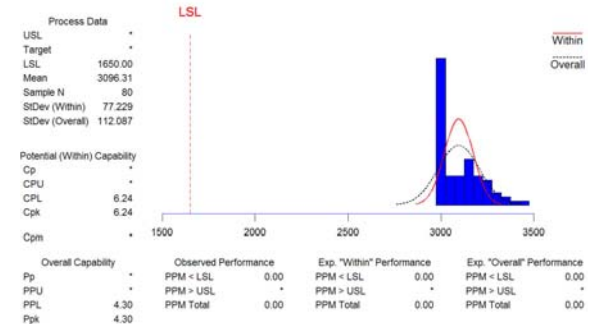
Process Capability Analysis for Sn63 NC No Solder Mask

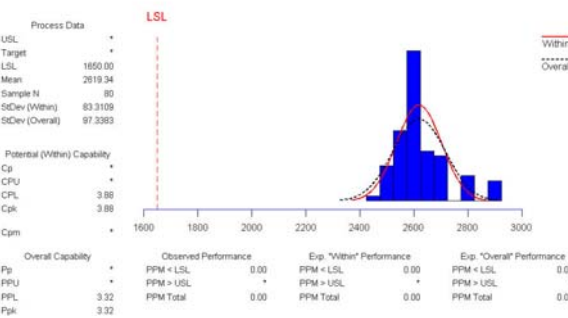
Process Capability Analysis for No Solder Mask with slot

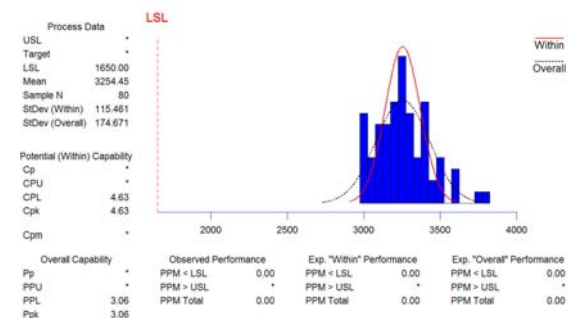
Process Capability Analysis for Sn63 NC No Solder Mask w/Slot

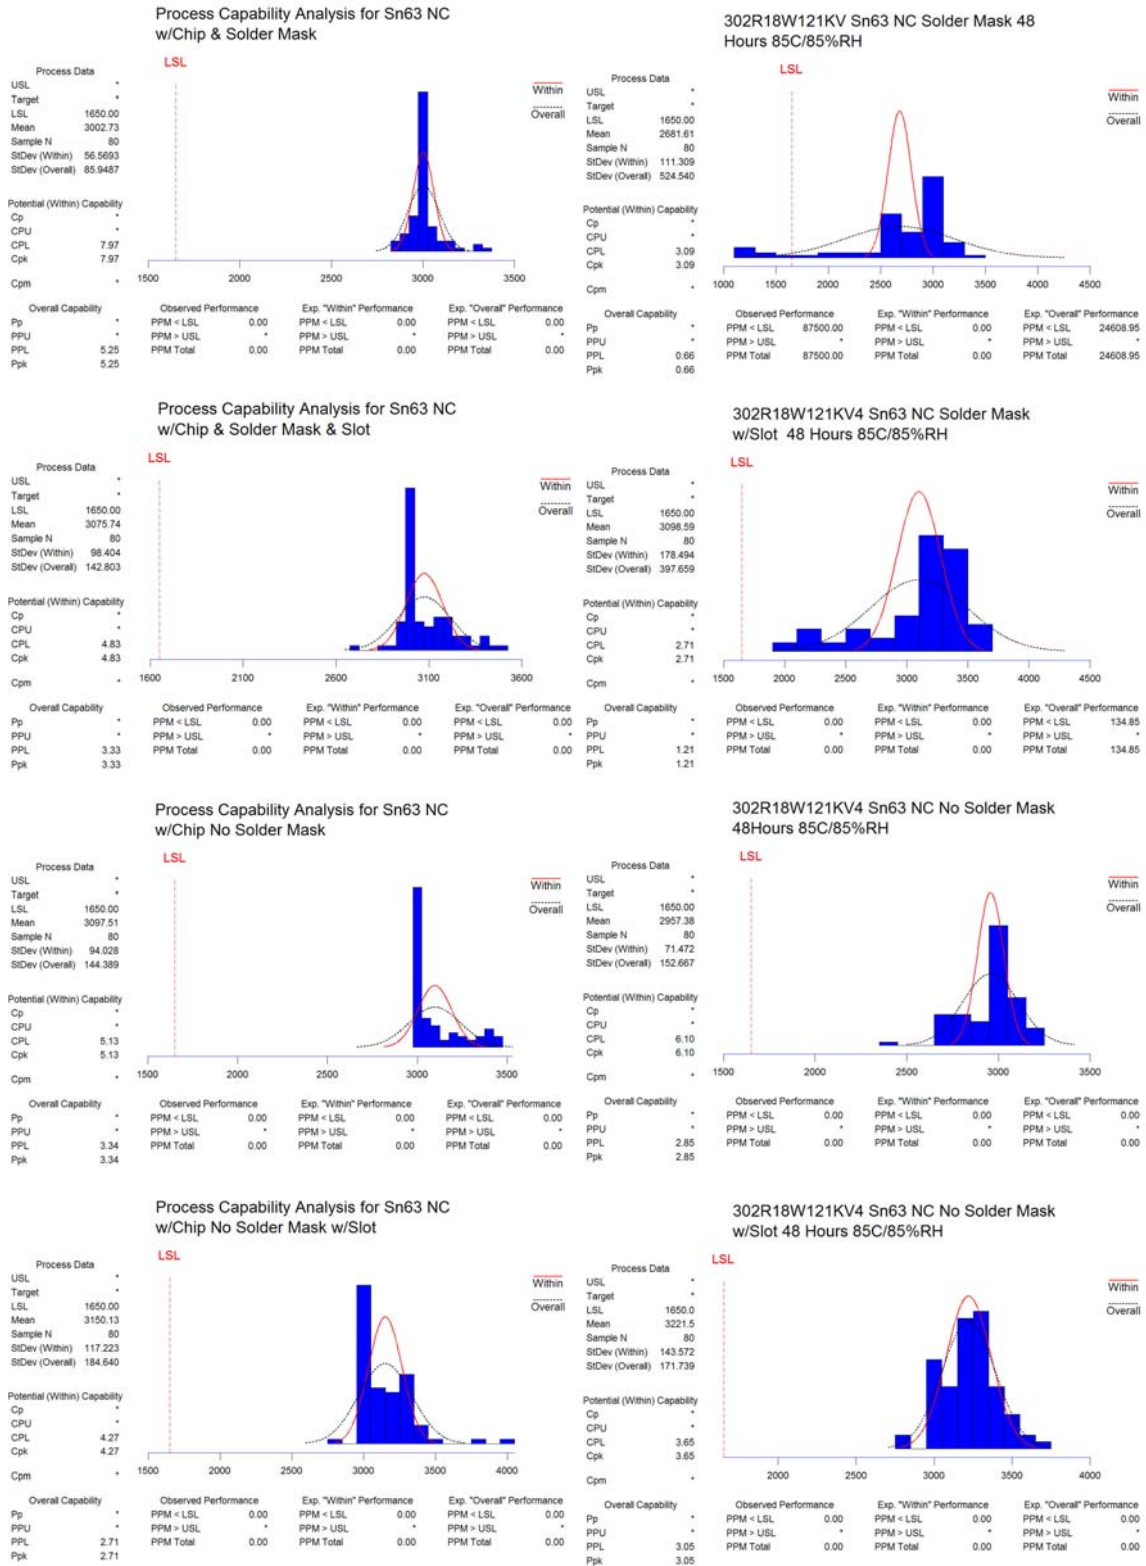
Appendix 2. AC Breakdown Results for Capacitors Reflow Soldered w/Sn63 No-Clean Flux With and Without Humidity Exposure

Appendix 2 lists AC breakdown results for capacitors reflow soldered to an evaluation board with No-Clean solder paste, tested approximately 18 hours after reflow soldering and an assembly that was exposed to 85°C at 85% RH for 48 hours and then tested 1 hour after the board was removed from humidity exposure. Appendix 3 has assembled board breakdown results approximately after two hours after cleaning. This assembly used water soluble solder paste. The other breakdown data is for an assembly with capacitors and water soluble solder paste, reflow soldered, cleaned and exposed to 85°C/85% RH for 48 hours. This assembly was tested to breakdown within 2 hours of humidity exposure. Table 2 is a summary all of the AC breakdown results shown in the appendices.

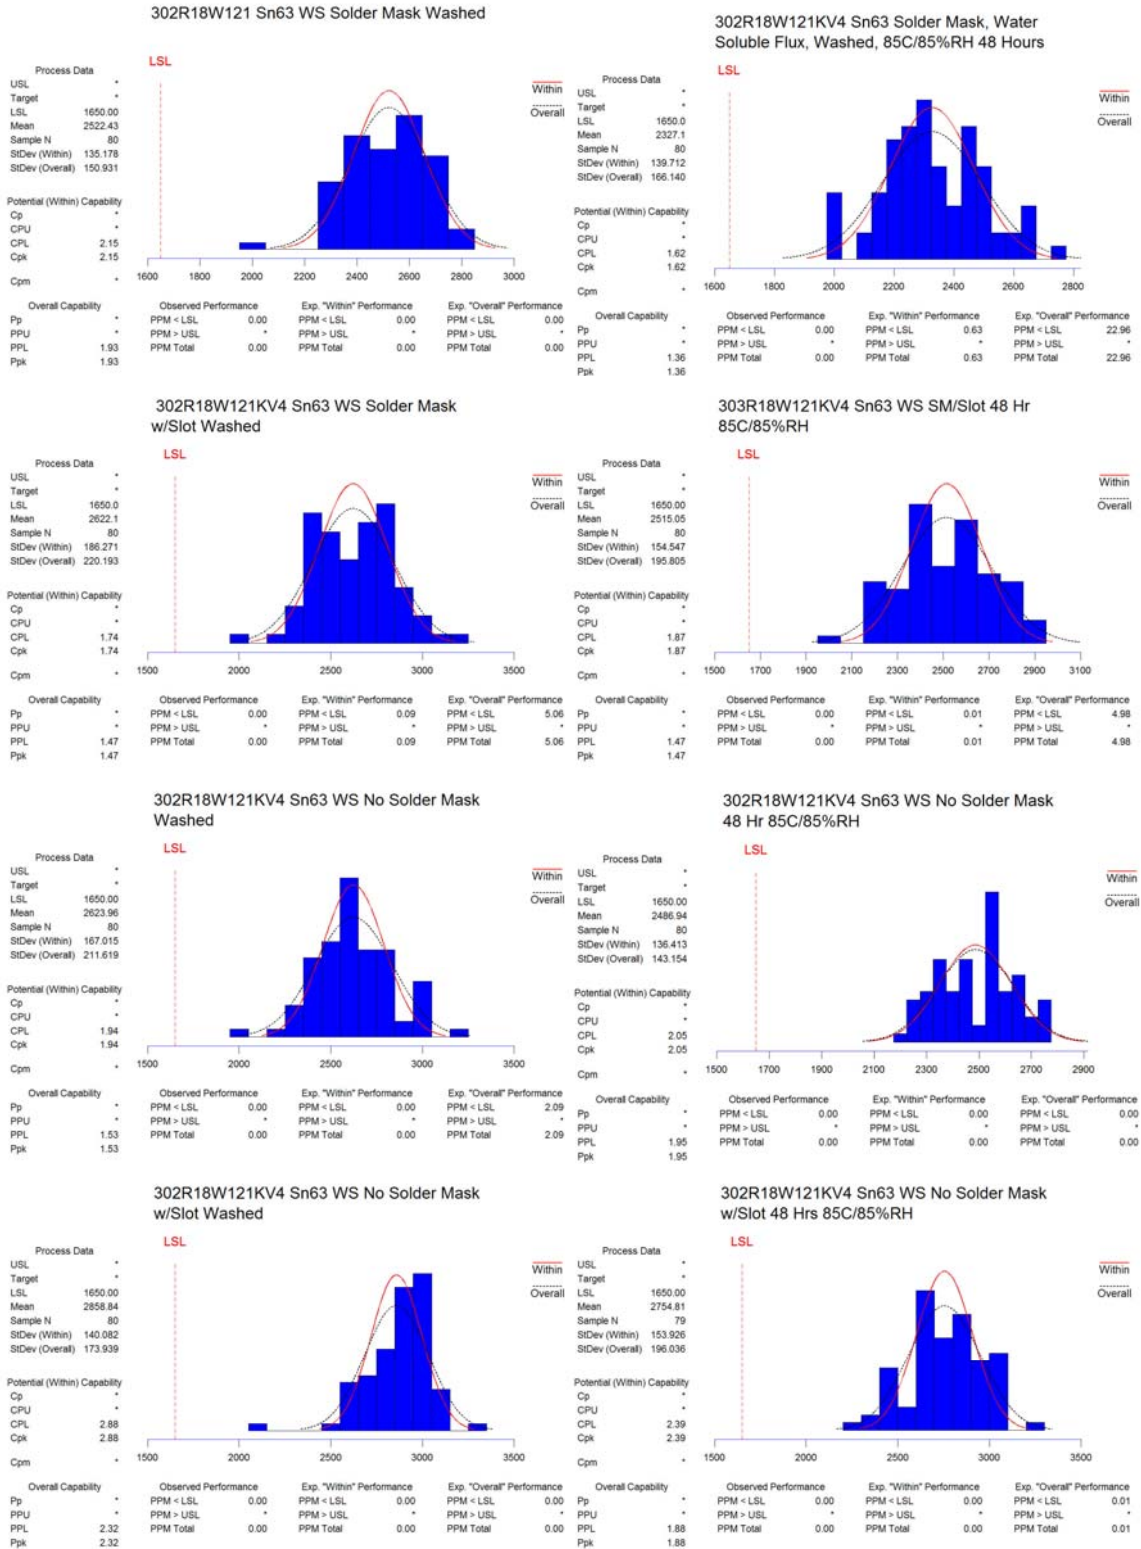
Appendix 3. AC Breakdown Results for Capacitors Reflow Soldered w/Sn63 Water Soluble Flux With and Without Humidity Exposure
